This note affects a specific revision of the iMX6 SoloX COM board (product number: EAC00244). The board is also sold as part of the iMX6 SoloX Developer's Kit (product number: EAK00245).

Note about simultaneous Ethernet #0 and Parallel RGB interface usage

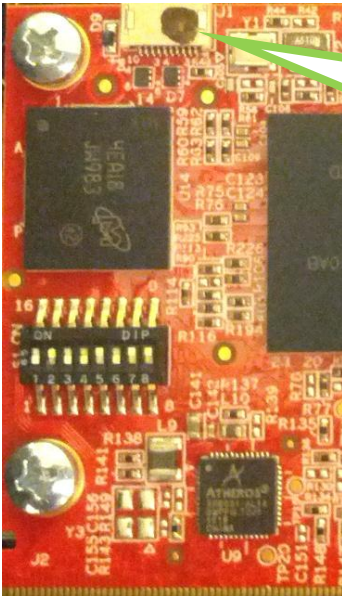
A black dot on the debug connector indicates that the board has already been reworked and is NOT affected by this note.

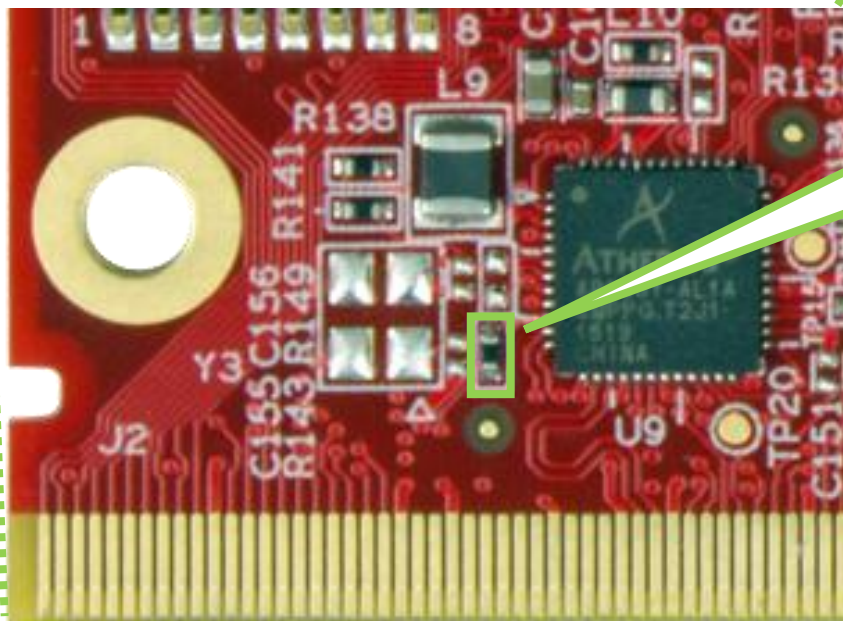
When the parallel RGB interface is active, under some circumstances a reference clock signal to Ethernet interface #0 is affected. This make it impossible to have reliable Ethernet communication on interface #0 (at the same time as the parallel RGB interface is active). The underlying reason is improper impedance matching of the Ethernet reference clock, causing ISI noise.

Replace R143 with a 20, 22 or 30 ohm resistor (0402-size). See pictures below to locate R143.

Replace R143 with
20, 22 or 30 ohm
resistor (0402-size).
